Pipe Bursting in Brazil

Removing Brazilian Water Leaks Using Trenchless Results in Major Savings

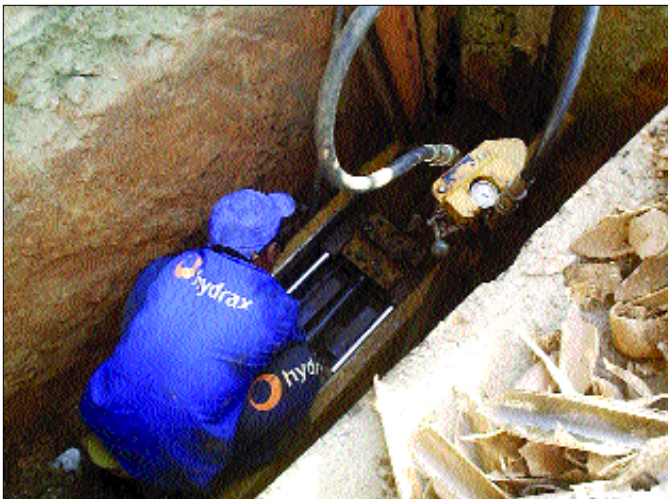
A Hammerhead HB3038 pipe bursting rig in operation on the City of Jaguariuna pipe replacement project.

In Jaguariuna, the bursting unit used was a HydroBurst HB3038 pipe bursting system. It is a system that has been used on water, gas and sewer replacement projects around the world.

The compact and versatile 38-ton capacity bursting machine is designed primarily for smaller diameter gas and water replacement from 50 to 150 mm. It can replace 100 m of pipe in as few as two hours. The HB3038 features quick replacement jaws, an on board pressure gauge, auto rod grip and release and rods that feature a double taper quick couple thread design. In addition, the HB3038 can be adapted to pull with a smaller diameter bursting rod. The smaller diameter rod allows operators to work in more heavily encrusted pipes between 50 and 75 mm in diameter. The rig size is just 152 mm long by 51 mm wide by 30 mm high, enabling it to work in tight footprint conditions and limited access situations.

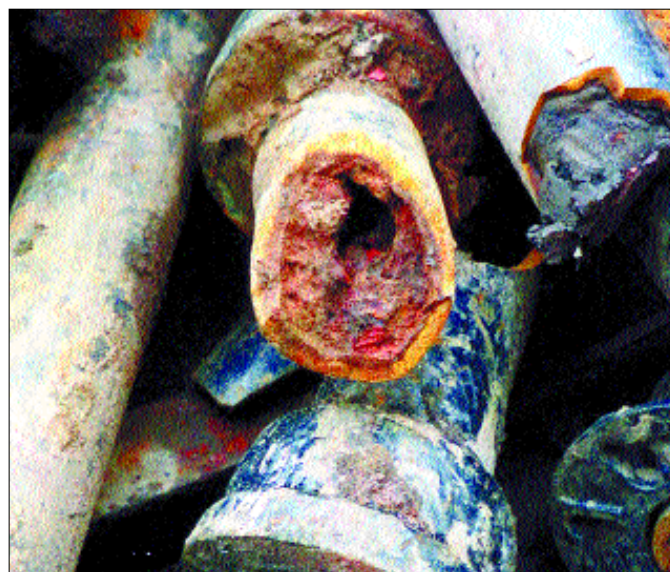
An example of the condition of the old pipes that are being replaced on the Jaguariuna pipeline project.
